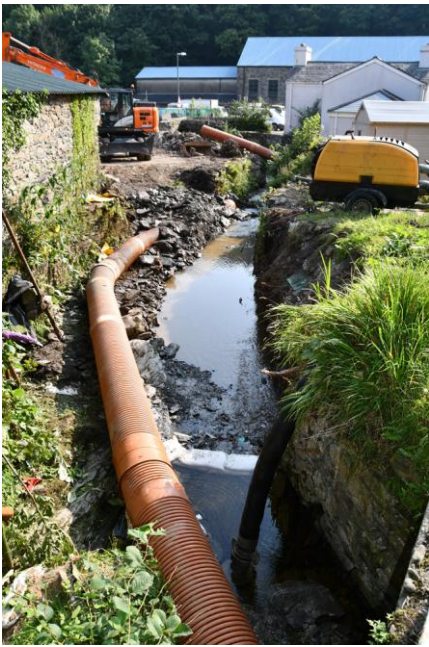
You will no doubt recall that I emailed you yesterday to pass on the concerns of local residents who were worried (understandably) that the comparatively tiny pipe being installed by the DOI in the culvert would be totally insufficient to handle the flow in the event of heavy rain.

1. Yesterday, showing installation of small pipe.
2. This morning (pipes swept away).
3. Culvert under road, which was filled to roof level.

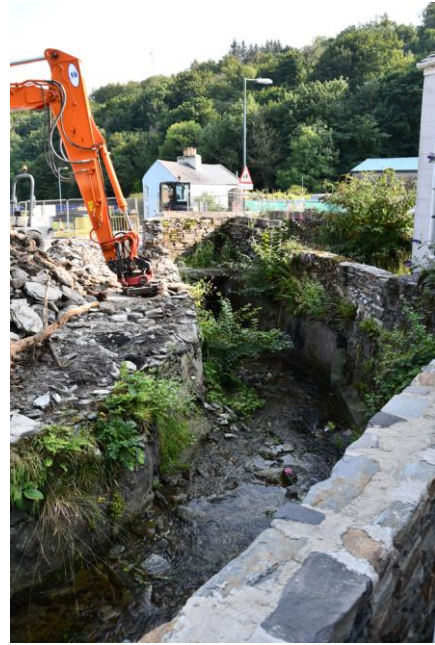
2.

As you now probably know, our exact fears came true at about 0200 last night, when the culvert overflowed through the small access hole made in it's roof, showing that it was indeed full to capacity.

Local weather records show that this occurred little more than an hour after commencement of the rain - exactly as we predicted, the culvert delivering - again as predicted - approx. 1000 tonnes of water per minute to the river.

The tiny 0.5 metre pipes (Prob. max. capacity around 60 tonnes/min) were, of course, swept away, and presumably lost.

- A. The new culvert must be completed before the old one is restricted in any way.
- B. IN NO CIRCUMSTANCES should the capacity of the new culvert be less than the existing one.
- C. Views of local residents - who have long experience of this culvert - be sought and respected.
